NOTICE OF VIOLATION FOR SANITARY SEWER OVERFLOWS, CALIFORNIA DEPARTMENT OF CORRECTIONS–MULE CREEK STATE PRISON, AMADOR COUNTY

INSPECTION REPORT

DISCHARGER: CALIFORNIA DEPARTMENT OF CORRECTIONS, MULE CREEK
STATE PRISON

INSPECTION DATE: 11 August 2020

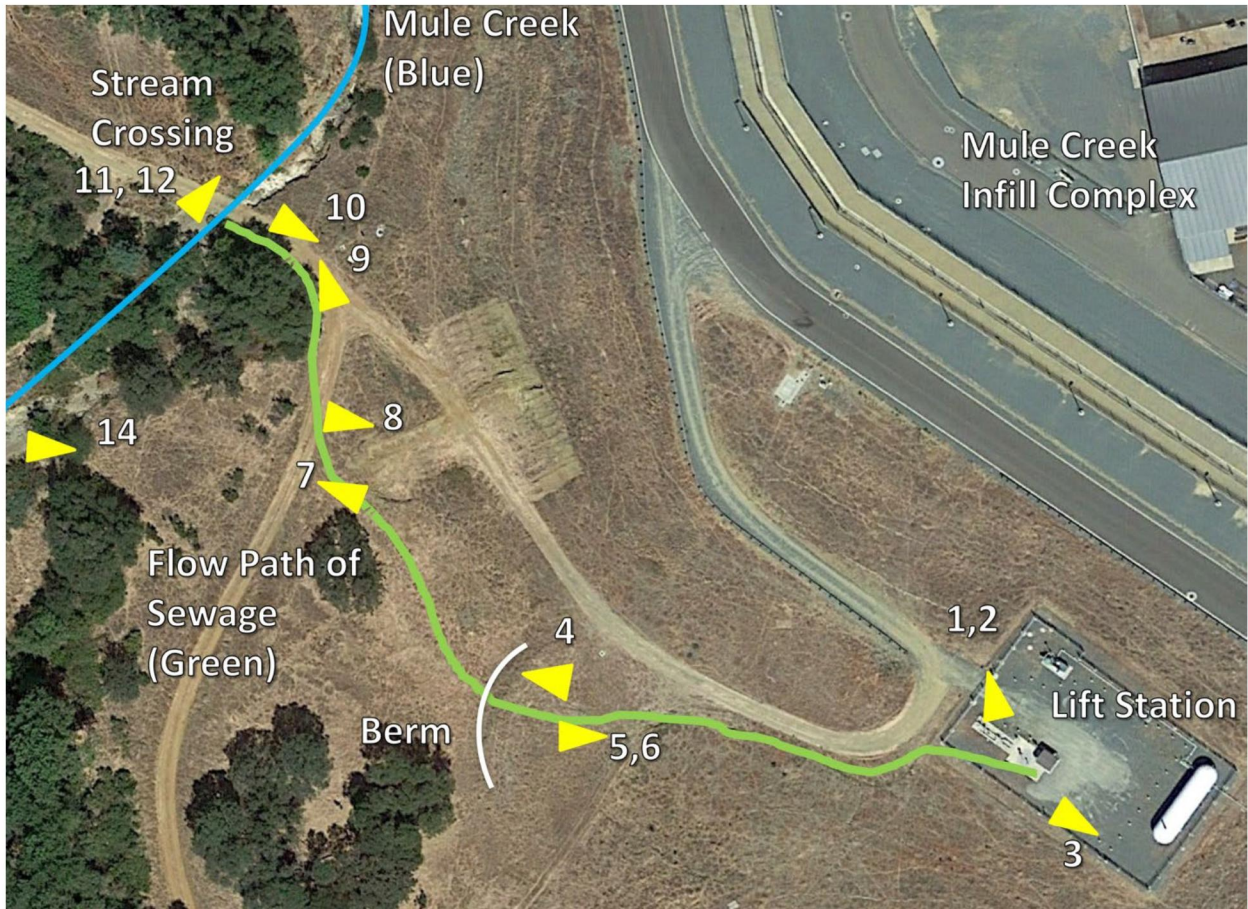
Photo Log Map 1: The locations where pictures 1 through 14 were taken are detailed on this map. The larger end of the triangle is closer to the subject in the photo.

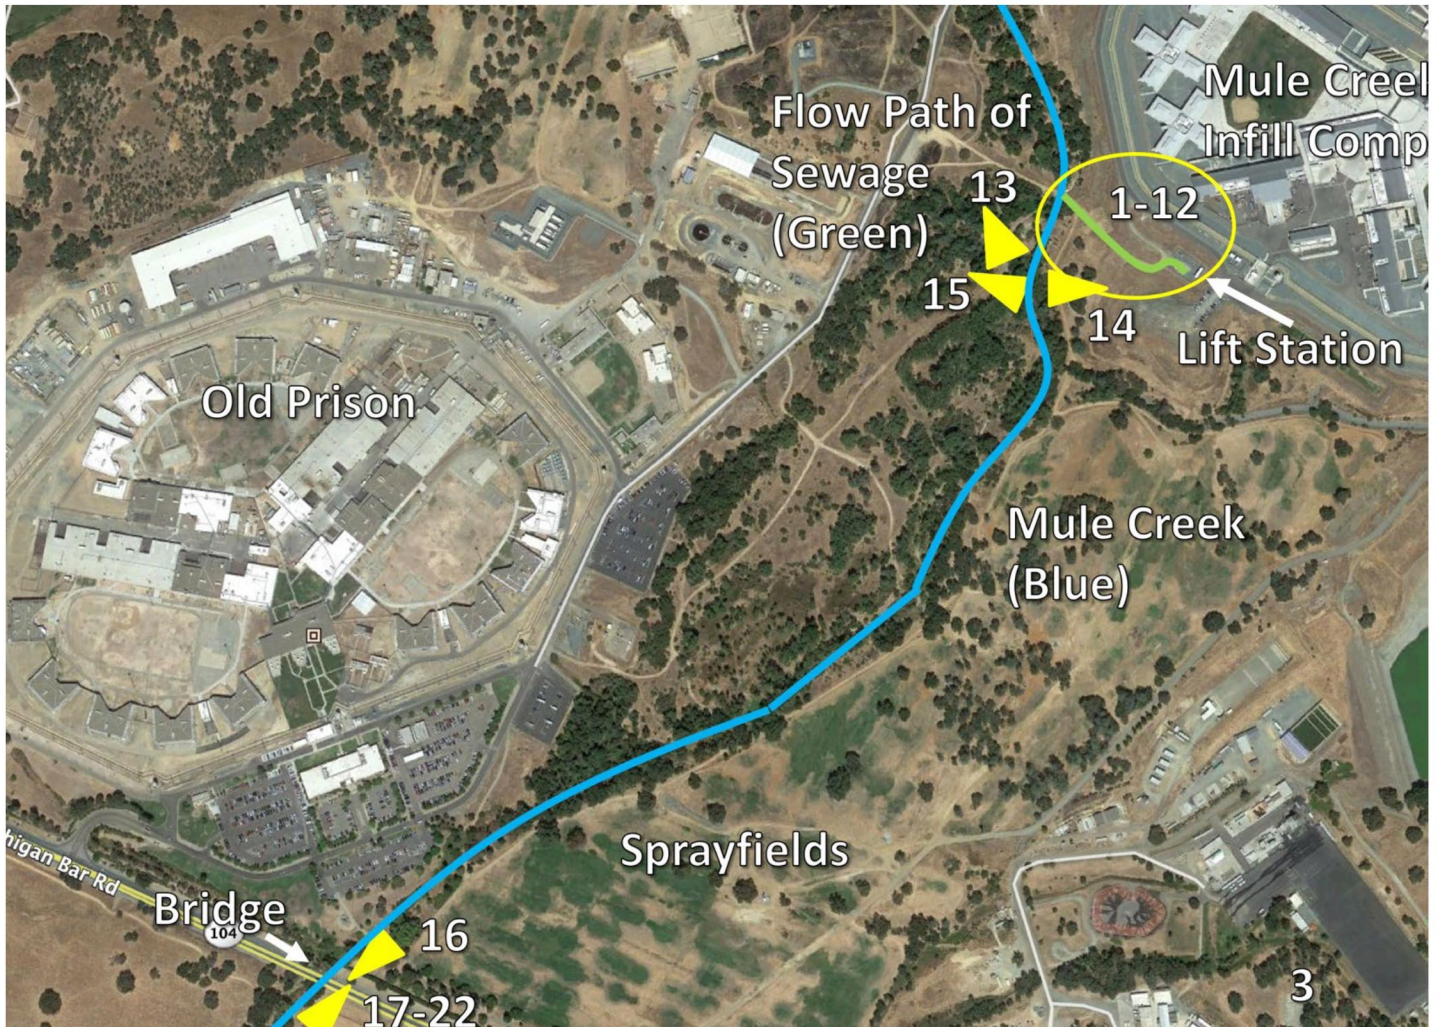
Photo Log Map 2: The locations where pictures 1 through 22 were taken in relation to the entire facility. The larger end of the triangle is closer to the subject in the photo.
